A method to replace lightning strike tests by ball impacts in the design process of lightweight composite aircraft panels

F. Soulas, Christine Espinosa, Frederic Lachaud, S. Guinard, Bruno Lepetit, I. Revel, Y. Duval

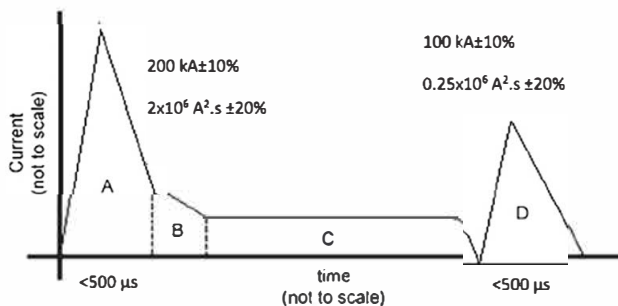
Fig. 2. Standard lightning strike current delivery used in aerospace industry [8].

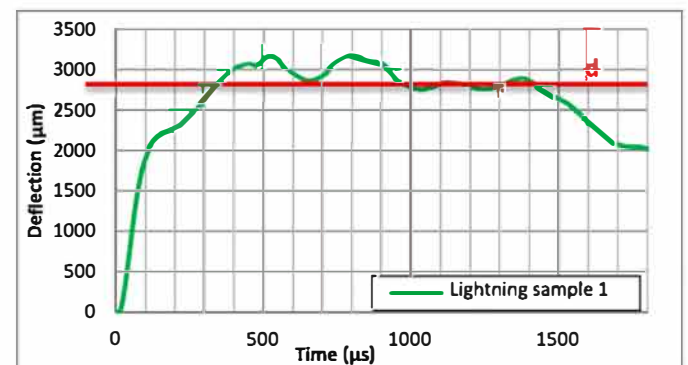
Fig. 9. Displacement vs time curve for lightning sample #1.

The deflection at large times is extracted from Fig. 9 and the corresponding impulse from Eq. 4. In plane Young moduli and Poisson ratios are obtained from standard laminate theory $E_{xx} = E_{yy} = 50.0$ GPa and $\nu_{xy} = 0.305$. The bending stiffness D (36.4 N/m) is chosen as the mean of the bending stiffness $D_{xx} = 51.8$ N/m and $D_{yy} = 21$ N/m of the composite plate for X (0°) and Y (90°) directions. The thickness h is 2 mm here, and the surface mass is $\mu = 3.1$ kg/m^2 .

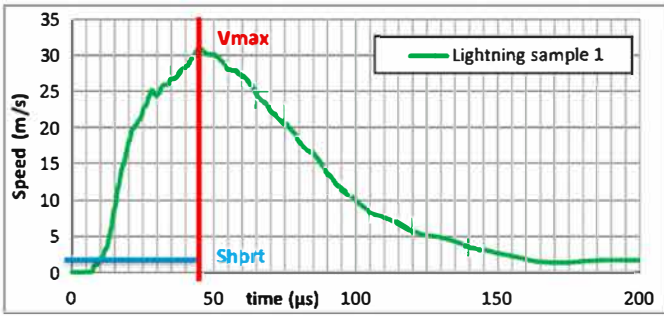
Fig. 10. Velocity vs time curve for lightning sample #1.

of a projectile of mass m , reaching the sample at the speed v , as a consequence of Eq. 3. As a first approximation the maximum speed of deflection measured during lightning strike tests is used as the speed of the projectile (e.g. $v_{max} = 29$ m/s for sample #1). The time duration to this peak value is also extracted as the "short time" which defines the equivalence time for further equivalent mechanical impacts. This duration T is of $47 \mu s$ (see Fig. 10). Then, the mass of the associated projectile can be calculated using $k = m \cdot v$. The obtained mass m is of 7.8 g for sample #1. Couples (m, v) associated to each lightning strike are thus obtained. In practice here the radius of the projectile is obtained from its mass using the steel density 7927 kg/m^3 .

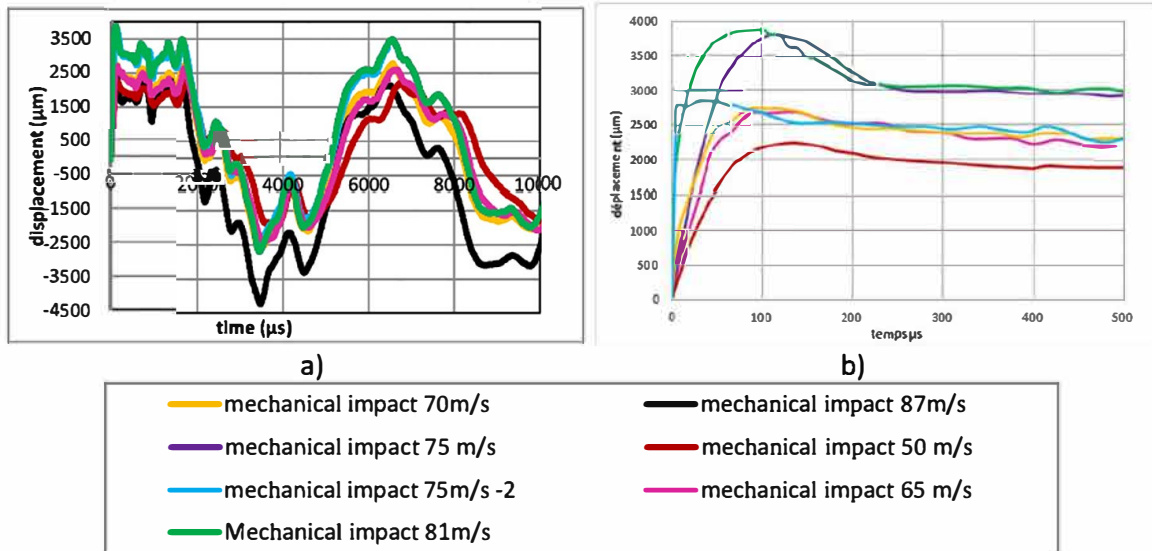
Fig. 13. Rear face displacement results (a) long time results for all tests (b) short time results (zoom between 0 to 500 μs).

Fig. 13 presents the rear displacement results for each MI test except the higher one at 124 m/s. Indeed, for the test case at 124 m/s the large splinter generated by the impact interfered with the displacement sensor which cannot follow the punctual displacement, thus, the first peak of deflection is not available for this case. Results

for the two tests at 75 m/s show some differences. It should be noted that 75 m/s is an approximate value of the real velocity which was more about 72 m/s for case 2 with a delay in the record for the very first instants while it was more about 77 m/s for case 1. The gap between those two tests is then of the order of 5 m/s. As expected, it can be seen that the higher the projectile velocity, the higher the first

deflection peaks. The natural vibration of the plate over time is clearly visible at large times with the particular shape of the first peak due to the impact of the projectile. It is presumed that all damages due to the impact appear during this first deflection peak and that the natural vibration of the plate beyond 100 μ s does not damage the sample anymore.

From Fig. 13, the different characteristic times are derived. 100 μs is obtained as the mean value for the short times of all experiments. 500 μs is obtained to be the large time, and d_{∞} can be obtained from the plateau values on each experimental curve. As the equivalence is made on a short time range (<100 μs) a focus on this period and on the first peak deflection followed by the displacement plateau is made in Fig. 13. As for the force, the maximum deflection increases with impact velocity. For all cases, this maximum value is included in the range {2 mm, 4 mm}.

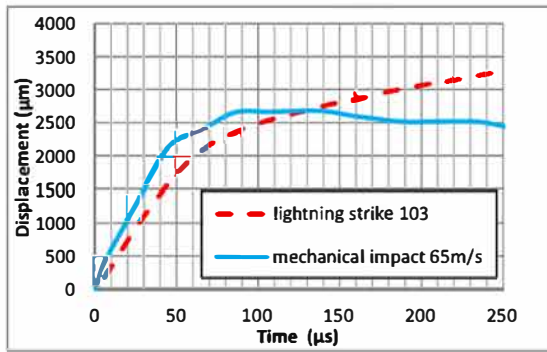
Fig. 14. Displacement versus time for the 65 m/s MI test (full line) and LS case 103 (dashed line).

A focus on cases 101 and 103 is presented on Figs. 14 and 15 respectively for impacts at 65 m/s, and 75 m/s. For lightning sample 103, which is totally covered by paint, the slope and values of displacement up to 50 μs ('short times') are quite close. Between 50 μs to 100 μs ('Strike times'), displacements are still of the same order of magnitude (about 2.5 mm), and both slopes change with different amplitudes (different decelerations). After 100 μs ('Stabilization times'), the two curves separate. The mechanical impact curve tends to decrease. The lightning strike displacement increases further.

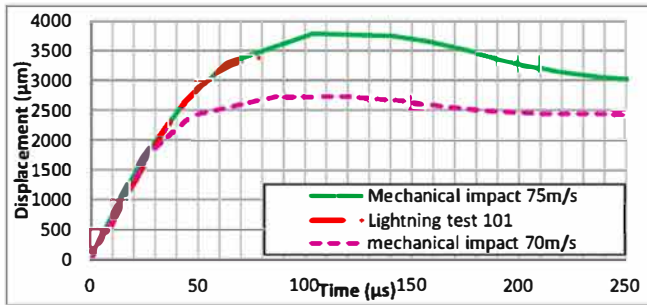
Fig. 15. Displacement versus time for the 70 m/s and 75 m/s mechanical impact tests and lightning strike cases 101.

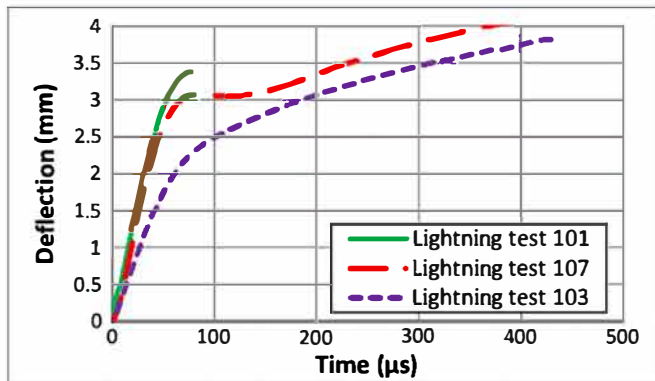
Fig. 16. Comparison of displacement for LS tests 101 and 107 (ECF195-160 μm paint).

The difference of displacements between samples 101 and 103 (Fig. 16) is due to differences in surface states. Remember that in the LS test 101, the paint was burned but not removed from the top layers. Sample 101, with 160 μm paint clearly shows a larger delaminated area as well as a higher displacement peak. The perturbation due to the paint also explains this strong difference: in the lightning strike test 101, the paint is burned on a very small part at the root attachment and so disturbs very soon and all the LS test long the global behaviour of the plate. For sample 103 on the contrary the lighter paint thickness was completely burnt so that the paint did not disturb for a long time the plate behaviour.

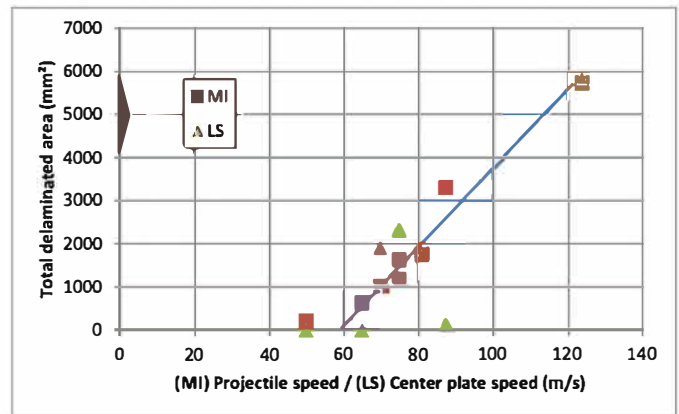
Fig. 17. Total delaminated area as a function of the velocity.

Fig. 17 presents the evolution of the total delaminated area as a function of the projectile's velocity for MI tests and the maximal plate speed for LS tests. As expected, the higher the projectile's velocity, the higher the damage area for both LS and MI tests. The curve can be approximated by a linear function of slope 81 mm.ms (R=0.94) or by a cubic curve which is more compatible with the limit of the contact impact approximation which creates large cracks in the rear face. The cubic approximation gives the delaminated area y as a function of the projectile velocity x with a regression coefficient of 0.98: $y = 0.04x^3 + 11.3x^2 - 854x + 20,097$. It can be seen that LS and MI curves are quite close, even for the high speed case at 124 m/s which was not good for rear face analyses. This again proves the validity of the model of equivalent impulse.

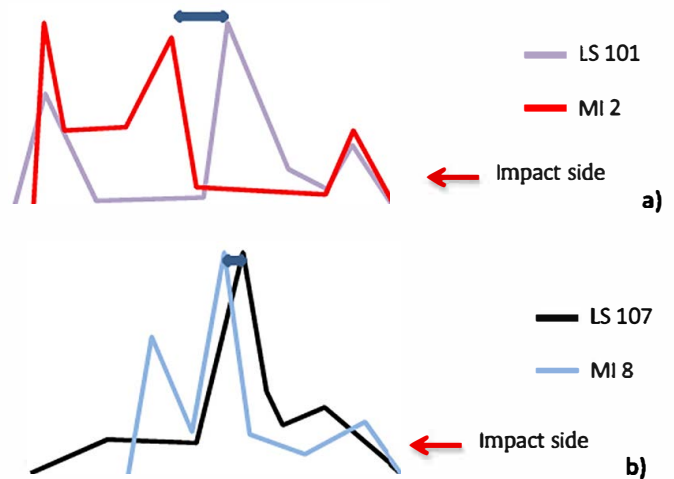
Fig. 19. Comparison of MI versus LS delamination profiles for cases 101 (a) and 107 (b).

Profiles extracted from the maximal values (**envelope**) highlight a great difference that is not yet completely explained, and could come from effects not taken into account here, in particular the impulse delivery surface which is a point for a sphere impact but evolves rapidly during the very rapid burning progress of the LSP layers up to a disk of about 12 mm diameter. This idea comes from analyses on geometric transformations both in abscissa and in ordinate of the envelope of the delamination profiles (Fig. 18), that are applied on the MI tests curves to fit the first delaminated peak (abscissa translation) and to the maximal delaminated area (scale factor on ordinate, second peak in LS tests). No scale factor is applied on abscissa. The result can be observed on Fig. 19. The offset between curves represents indeed the offset of delamination in different interfaces. The offset of delamination location is suspected to be due to the difference of loading rates between MI and LS that locates the peak stress responsible of the delamination onset at different positions in the depth. This phenomenon is described by Ecault et al. [19] who control the laser impulse to enforce the onset of delamination in a chosen interface.

For case 101, the MI tendency curve is delayed from 0.25 mm in abscissa which coincides with one ply thickness, and scaled in ordinate by a factor of 1.55 to fit the maximum delaminated area of the LS test. A distance of about one ply in thickness (0.25 mm) can still be observed between the two second peaks from impact side. A
