## A method to replace lightning strike tests by ball impacts in the design process of lightweight composite aircraft panels

F. Soulas, Christine Espinosa, Frederic Lachaud, S. Guinard, Bruno Lepetit, I. Revel, Y. Duval

F. Soulas, Christine Espinosa, Frederic Lachaud, S. Guinard, Bruno Lepetit, et al.. A method to replace lightning strike tests by ball impacts in the design process of lightweight composite aircraft panels. *International Journal of Impact Engineering*, 2018, 111, pp.165-176. 10.1016/j.ijimpeng.2017.09.007 . hal-01940478

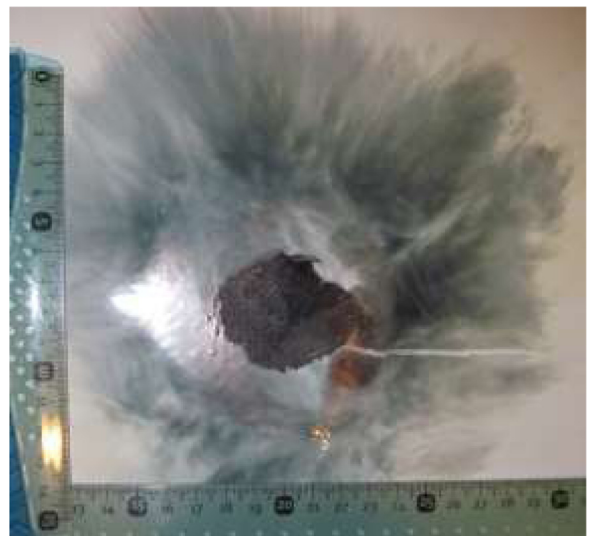
Fig. 4. Typical observable damage after D waveform LS test on a CFRP target.

Firstly, with the help of an interferometric apparatus, the rear face deflection and velocity of the samples have been measured versus time. Secondly, post mortem non destructive and destructive analyses were conducted to measure total delamination area and through thickness distributions. Typical surface damage areas essentially due to thermal effects are shown on Fig. 4: sublimation of the metallic mesh and removal of the paint above the protection as well as burning of the first ply's carbon fibres and epoxy resin.
