Analysis of hole wall defects of drilled carbon fiber reinforced polymer laminates

Soraya Catche, Robert Piquet, Frederic Lachaud, Bruno Castanié, Audrey Benaben. Analysis of hole wall defects of drilled carbon fiber reinforced polymer laminates. *Journal of Composite Materials*, 2015, 49 (10), pp.1223-1240. 10.1177/0021998314532668 . hal-01951221

ANALYSIS OF HOLE WALL DEFECTS OF DRILLED CFRP LAMINATES

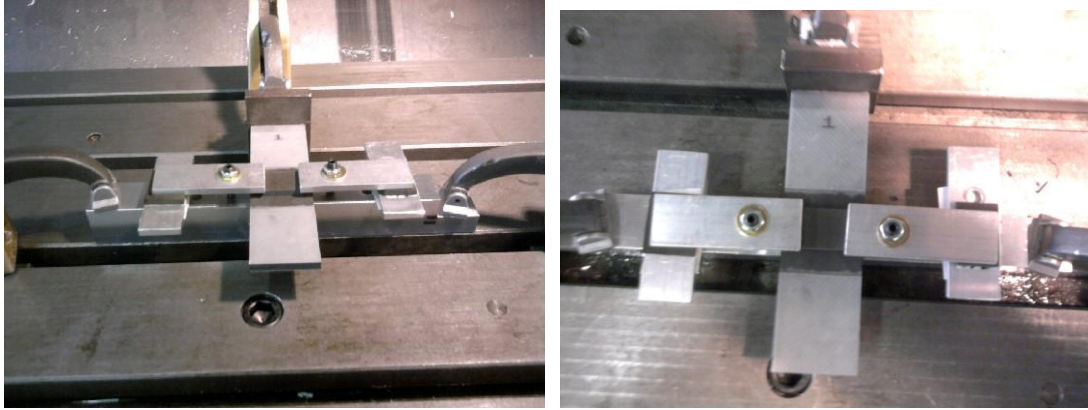
Fig. 1: Drilling device.

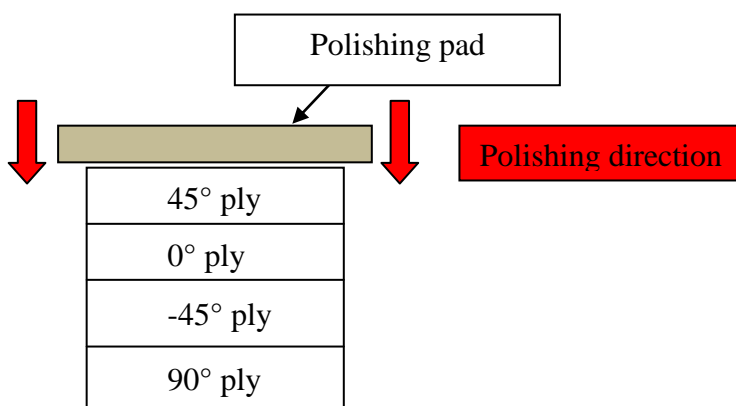
Fig. 2: Method for polishing specimens.

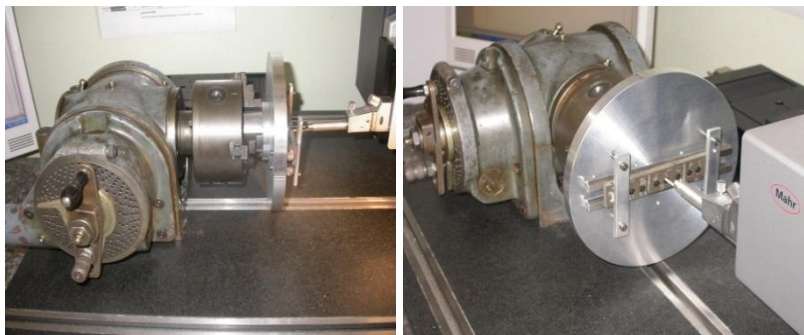
Fig. 3 Device for roughness measurements

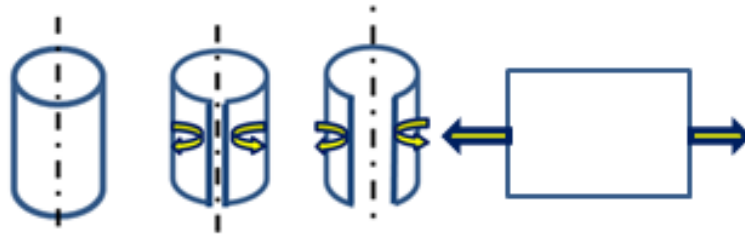
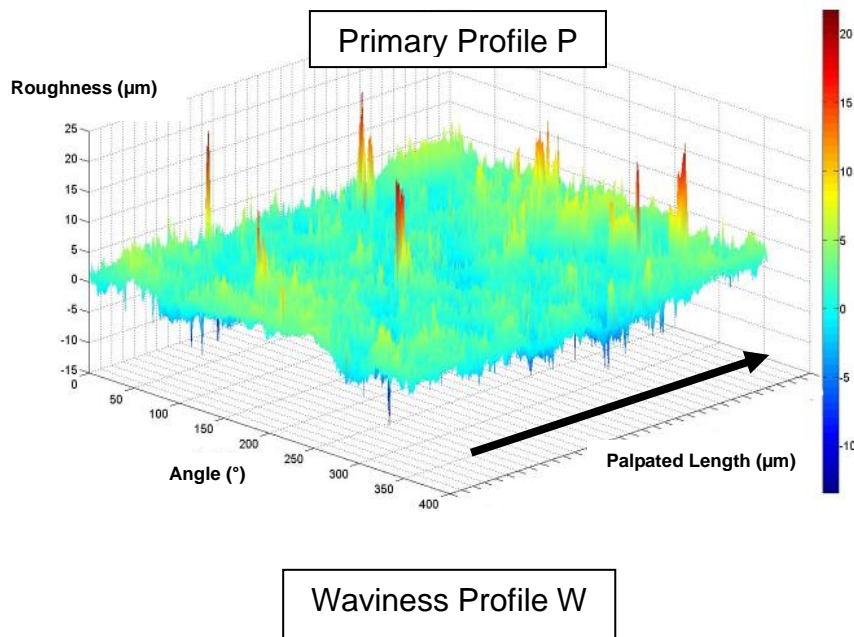
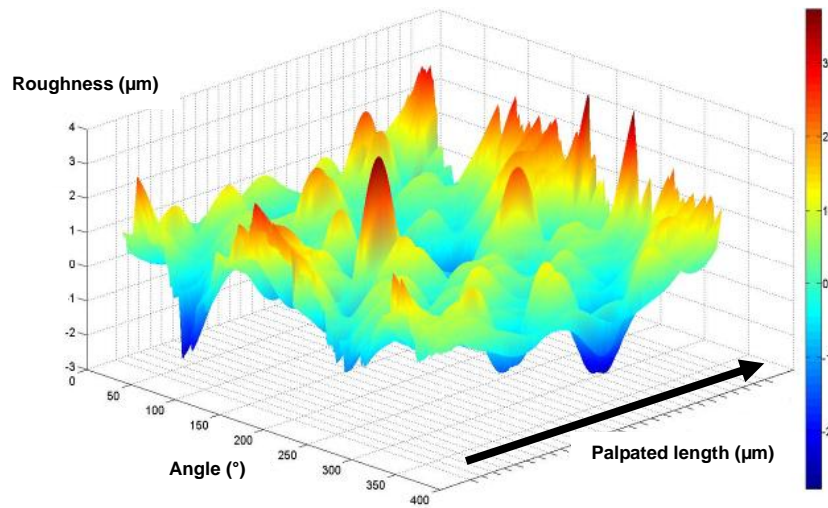
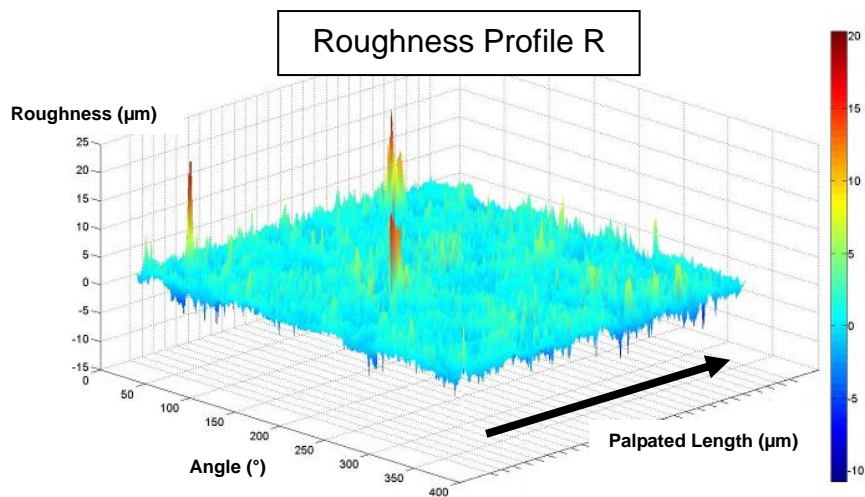
a) "Developed" hole surface

b) The three principal normalized roughness profiles : Primary, Waviness and Roughness (μm)

Fig. 4. Maps obtained with roughness measurements

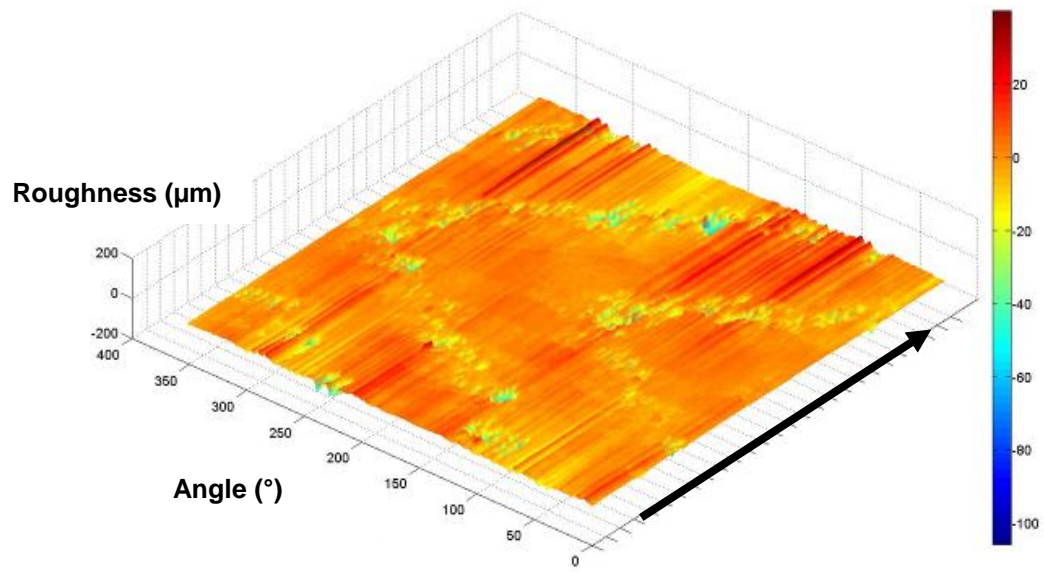
Fig. 5. Example of the primary profile of a hole with “V” pattern of defects

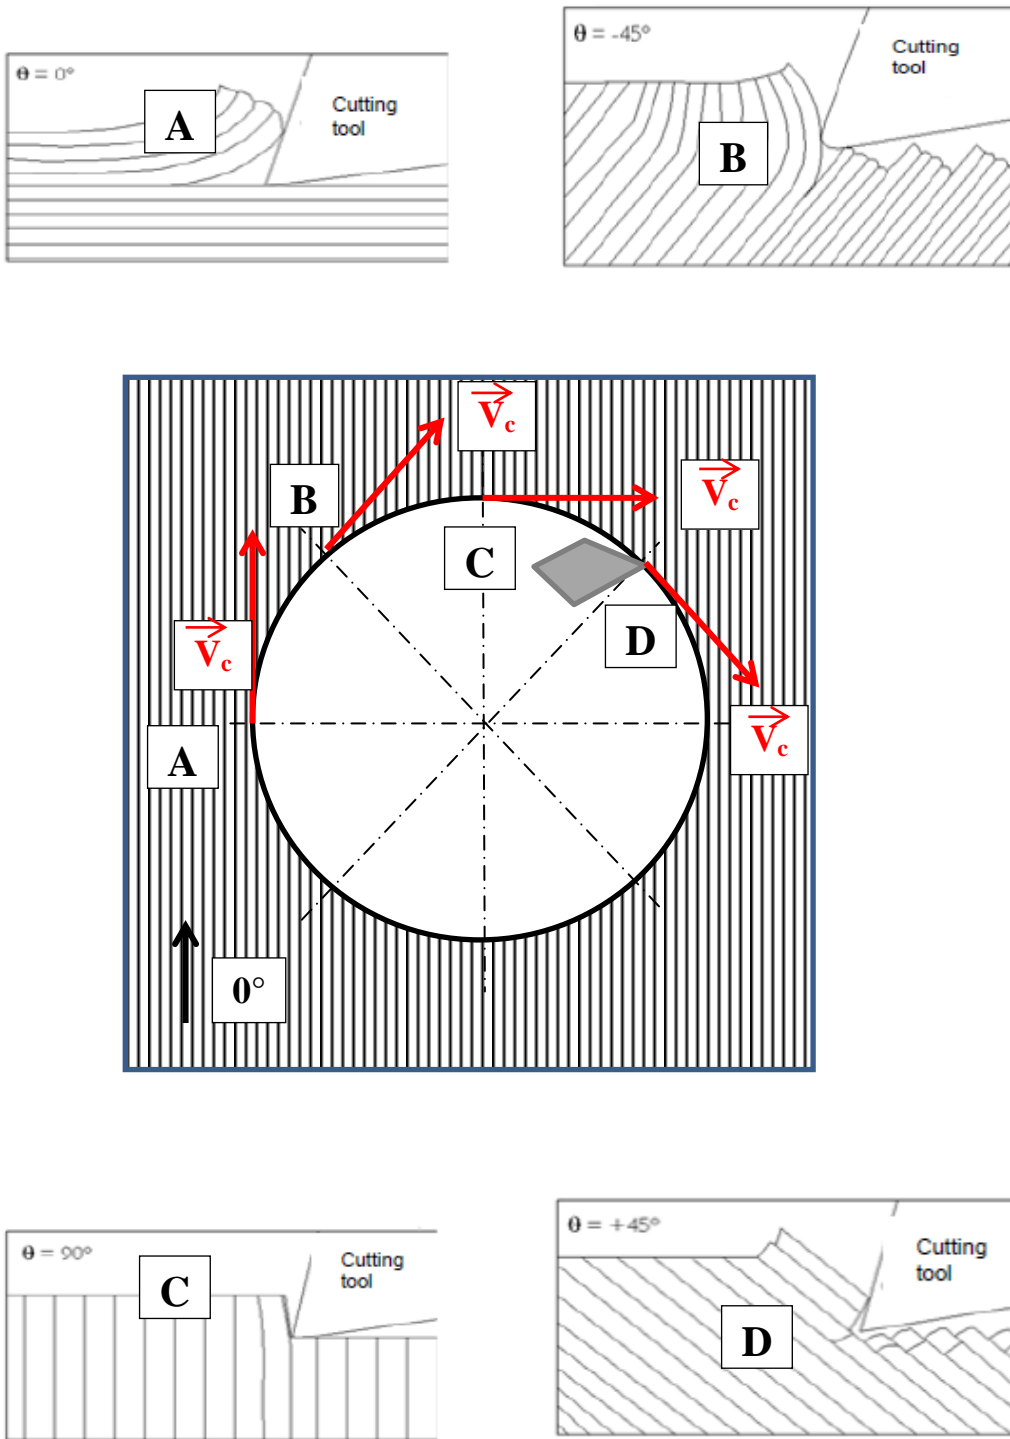
Fig. 6: Behavior of fibers under the cutting edge according to their orientation relative to the cutting speed direction.

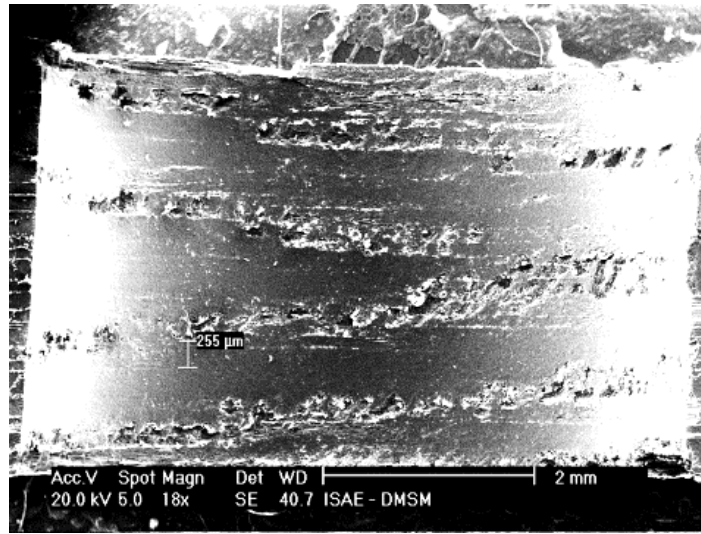
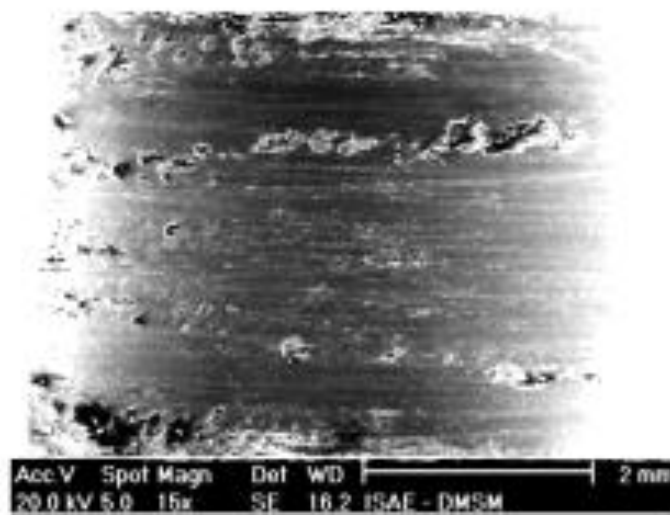
Fig. 7: Drilling defect locations for the two stacking sequences: Quasi-isotropic laminate (a) and Oriented laminate (b) .

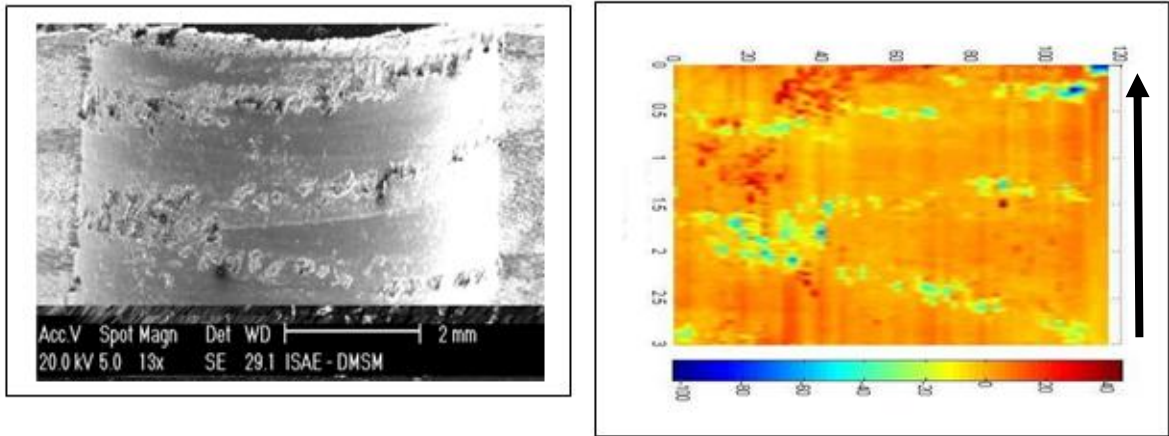
Fig. 8. Comparison between micrographic observations and roughness maps (quasi-isotropic stacking).

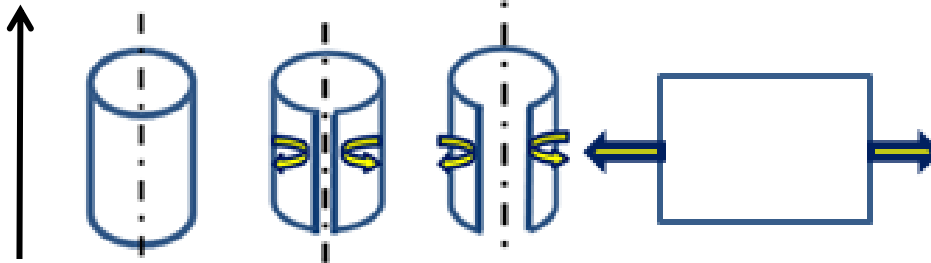
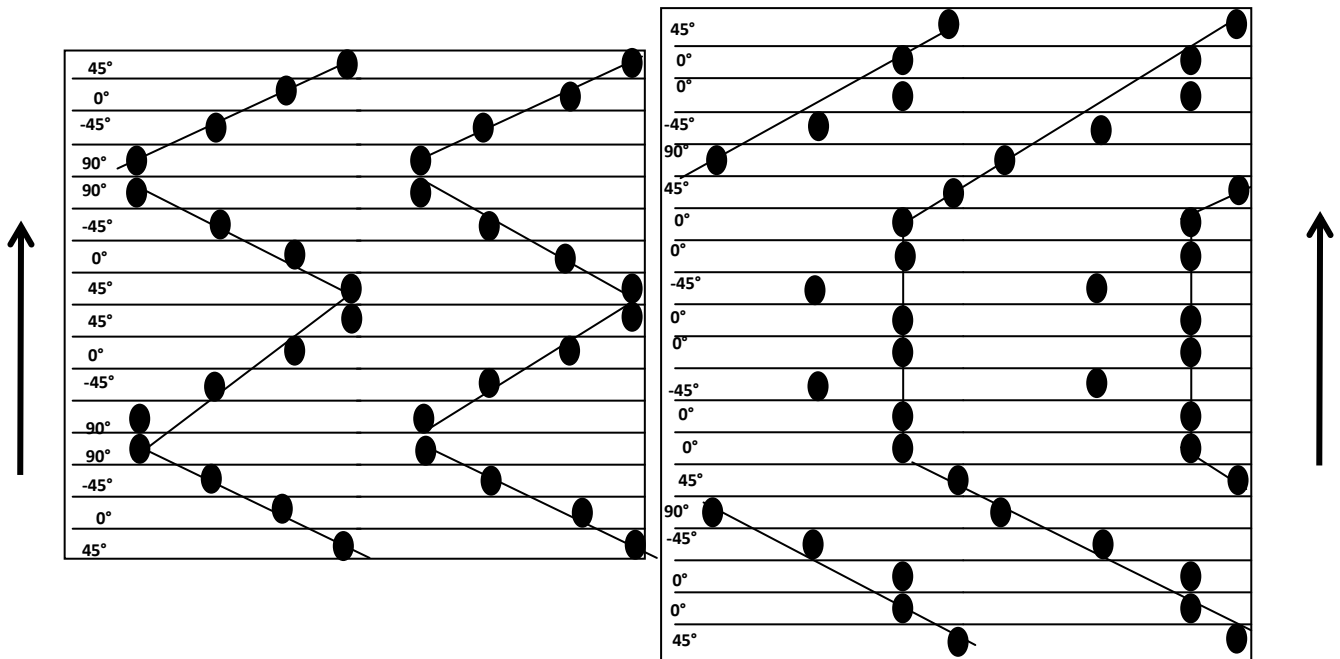
a) Principle of development of the hole

a) Quasi-isotropic laminate

c) Oriented laminate

Fig. 9: Drilling defect patterns predicted for the two stacking sequences by considering the worst defects.

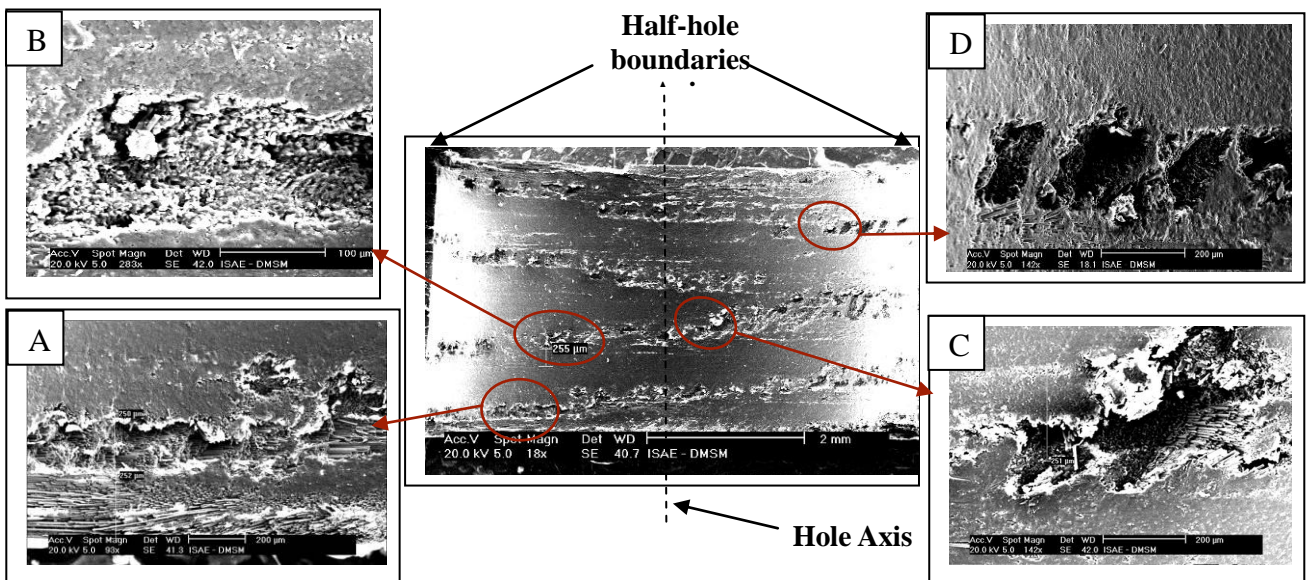
Figure 10. Microscopic views of largest wall defects (drilling configuration 3).

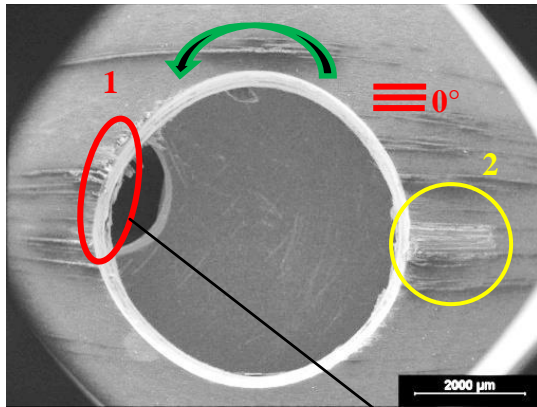
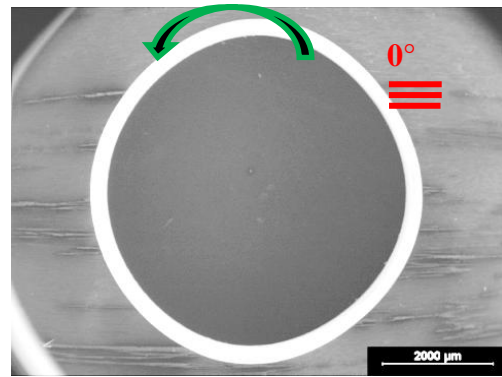
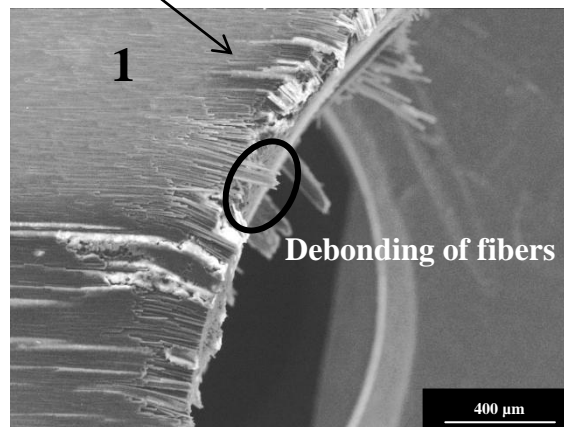
0° layer

a) Bad surface finish

b) Good surface finish

Fig. 11: Drilling defects on the 0° ply. (a): drilling configuration (3); (b): drilling configuration (1)

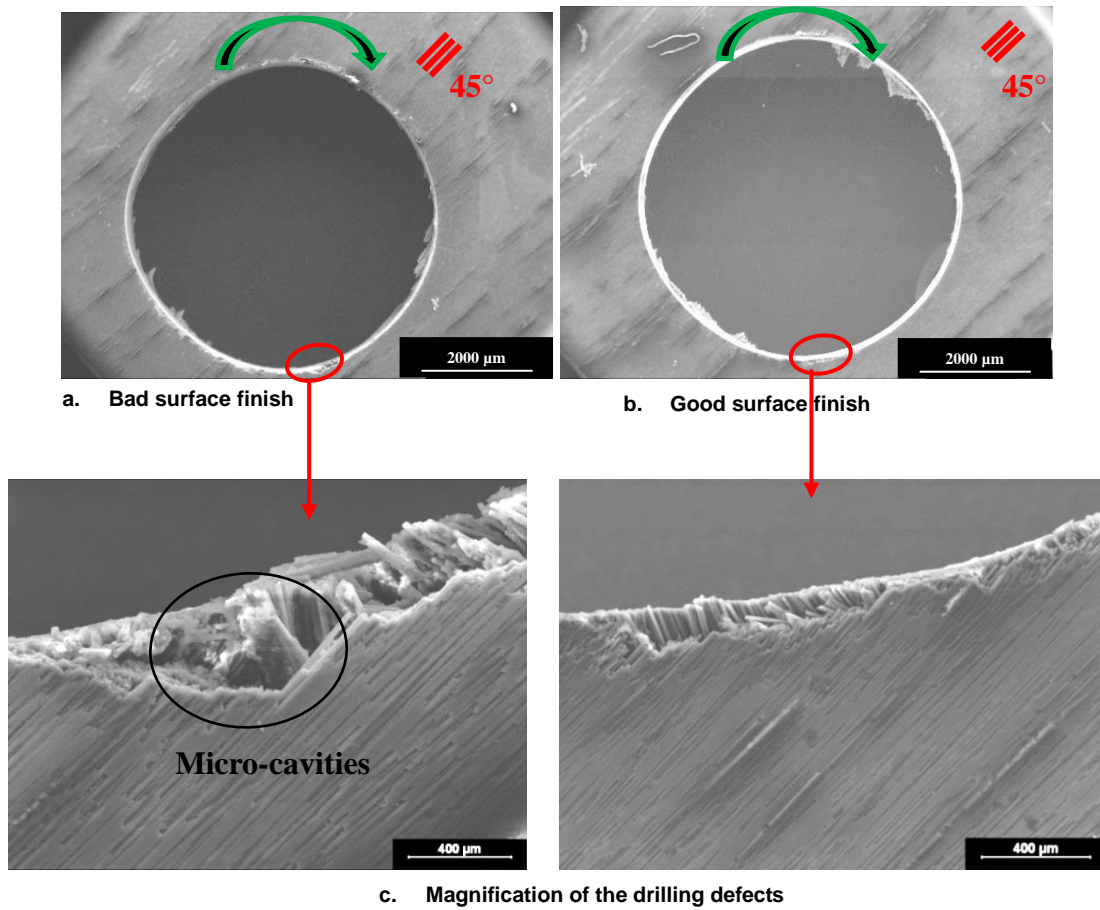
45° layer

Fig. 12: Drilling defects on the 45° ply. (a): drilling configuration (3); (b): drilling configuration (1)

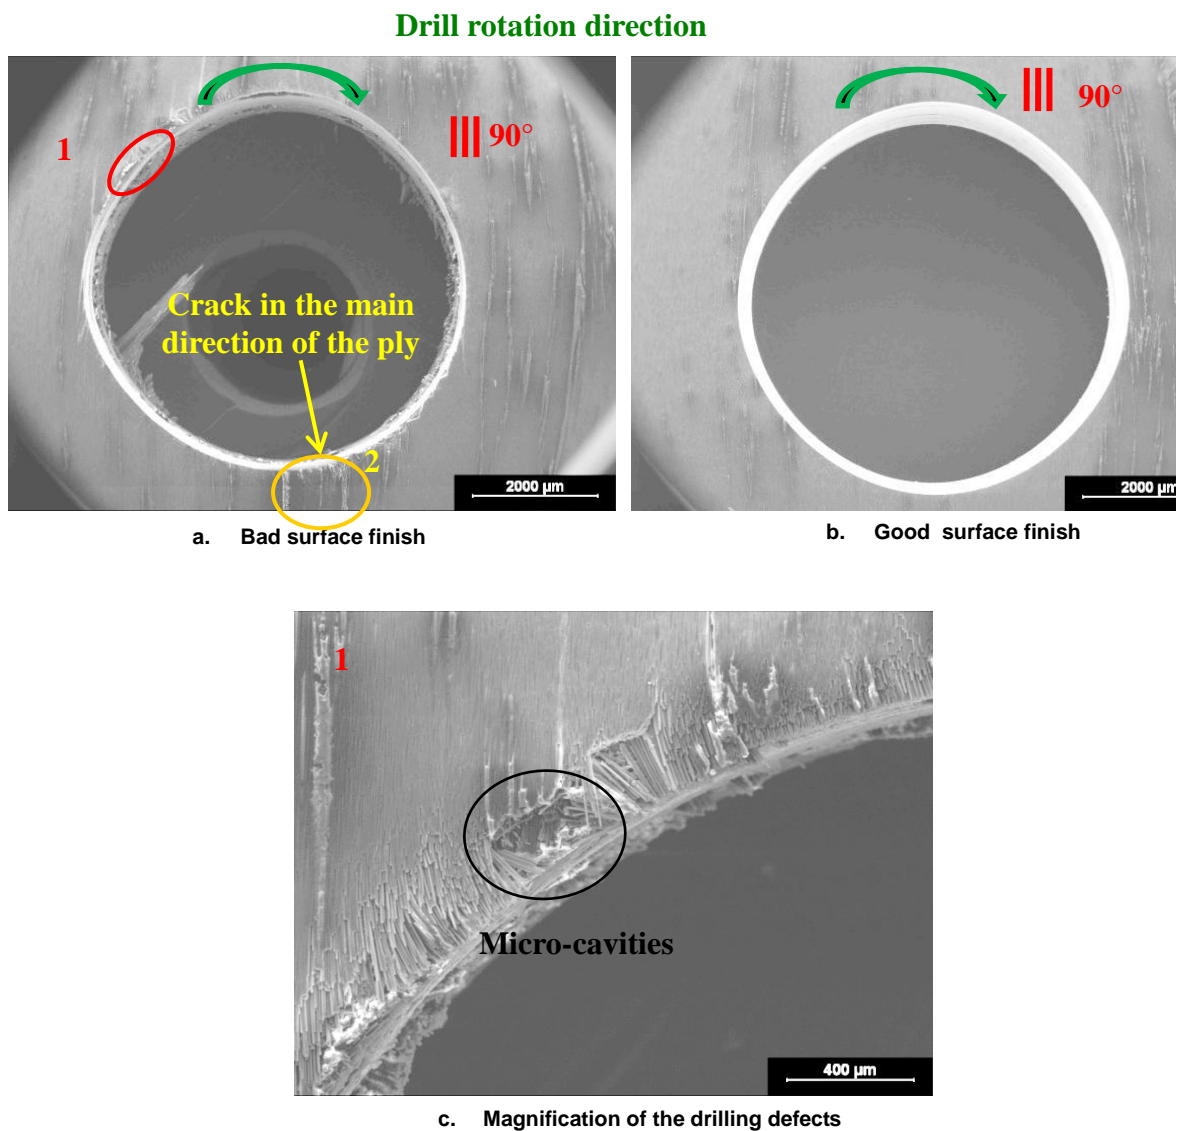
90° layer

Fig. 13. Drilling defects on the 90° ply. (a): drilling configuration (3); (b): drilling configuration (1)

The main defects of 90° ply (Figure 13) were located at -45° and 135° relative to the direction of the ply and the drill rotation direction. These defects were mainly pull-out of fiber bundles. Figure 13c shows that the fibers have been pushed following the direction of drill rotation. Some of the fibers have been pulled down while others have bent under the action of the cutting edge but have not been “broken”. The specimen on the right shows good surface finish, but there are still some deep cracks in the ply.

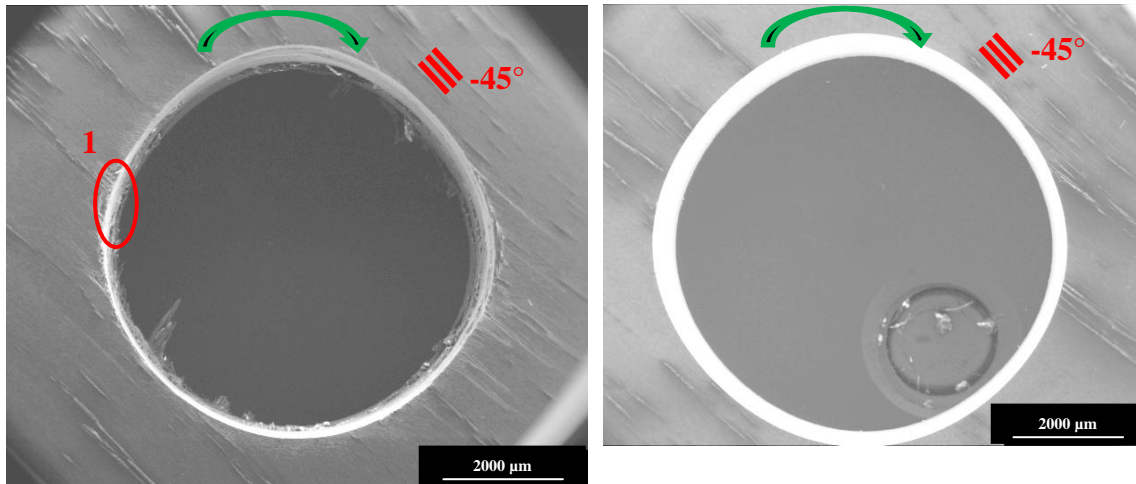
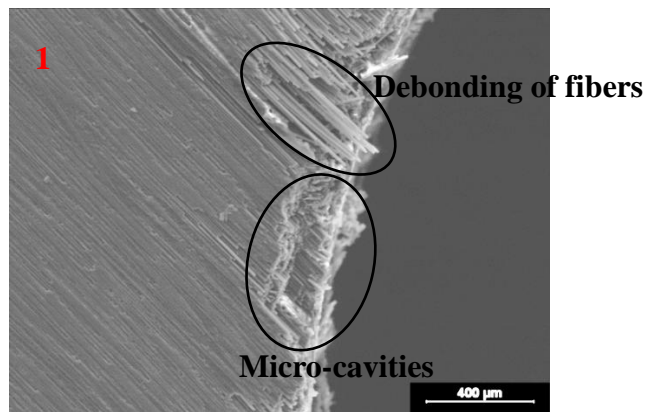
-45° layer

a. Bad surface finish

b. Good surface finish

c. Magnification of the drilling defects

Figure 14: Drilling defects on the -45° ply. (a): drilling configuration (3); (b): drilling configuration (1)

For the last direction (-45°), the main defects were located at -45° and 135° relative to the direction of the ply and the drill rotation direction (Figure 14). These defects had the shape of micro-cavities in the ply thickness. Debonding of fibers can be observed in the main direction of the ply. These fibers protrude from the machined surface. It is also clear that such depth defects, which may eventually affect the mechanical strength, cannot be detected by measuring roughness.

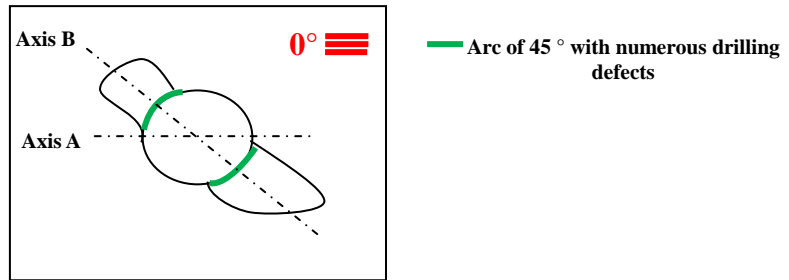
Fig. 15. Location of drilling defects

This micrographic analysis confirms the quantitative analysis proposed on the location and the type of defects created during a drilling operation. The mechanisms of occurrence of drilling defects and their nature have been identified. The area with the largest drilling defects is located between two axes (Figure 15):

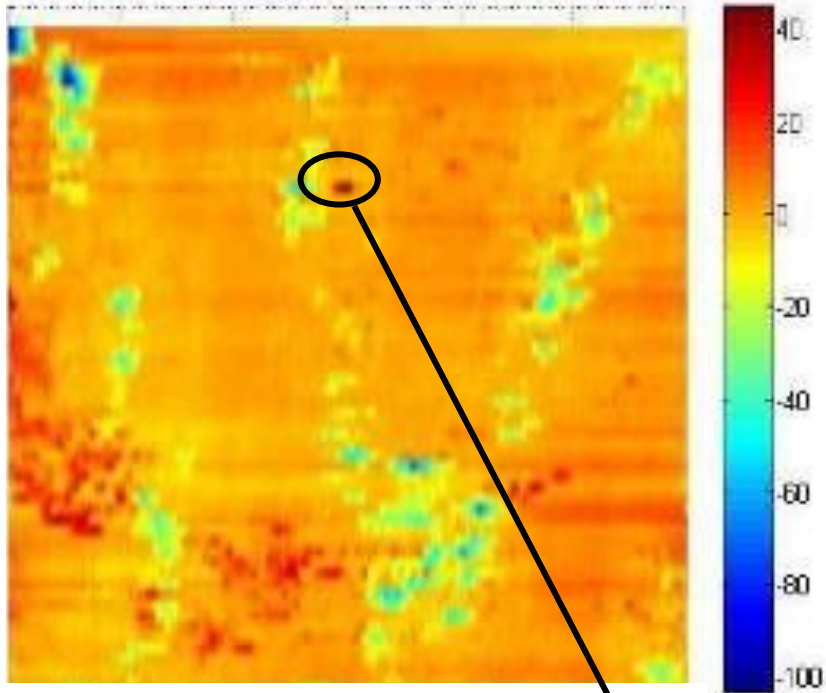
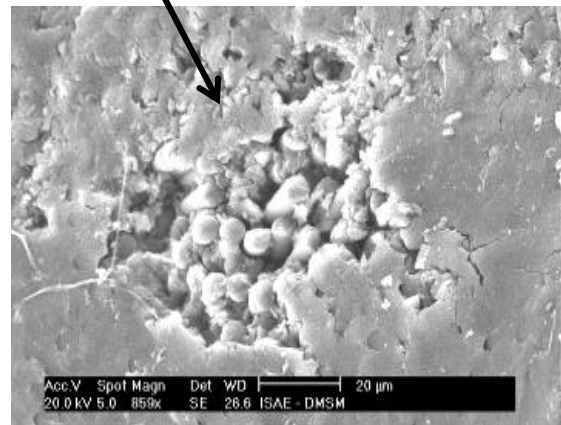
(a) Mapping made by the roughnessmeter

(b) Micrographic view of a red dot

Fig. 16. Analysis of protruding fibres through roughness mapping and micrographic view.

The largest drilling defects have the aspect of micro-cavities. But, as already pointed out, some fibers protrude from the machined surface. Figure 16a shows many red dots corresponding to *positive amplitudes* of drilling defects. The presence of these points can be explained by microscopic observations. One of the red dots was observed by SEM and is shown in Figure 16b. Fibers are clearly above the surface of the hole. Some fibers fell at the cutting edge in the drilling operation and were badly cut, protruding beyond the machined surface. This defect has already been identified by Ghidossi [36]. It occurs when the fibers are oriented at 0° with respect to the direction of cutting. However, in practice, this defect is not important because the fibers fold and do not carry the bearing forces of a bolt. For this reason, the total area filled by these drilling defects was assessed because, during the contact between the bolt and the hole wall, this area does not bear the bolt. The bearing surface is then the total surface of the hole wall minus the surface area occupied by micro-cavities. This criterion is important because it defines the percentage of the area of the hole wall that is in contact with the bolt. It represents a version of the damaged surface criterion proposed by Ghidossi [36] and extends over the entire hole. It is also defined in the ISO 13565-2, ISO 13565-3, and ISO 12085 standards (bearing length) and ISO 25178 for the surface. It was originally created to analyze the capacity of a bearing surface to retain oil locally for lubrication. Figure 17 represents the methodology for calculating the criterion of bearing surface.

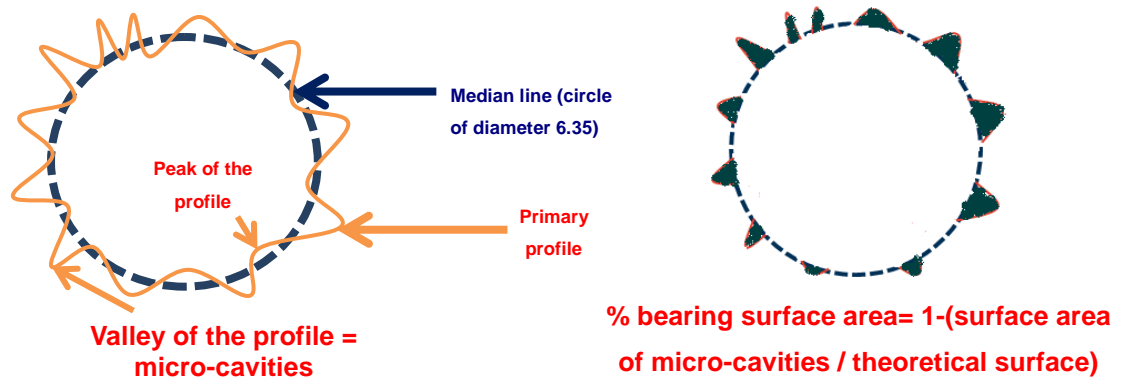
Fig. 17: Method for calculating the percentage of bearing surface.

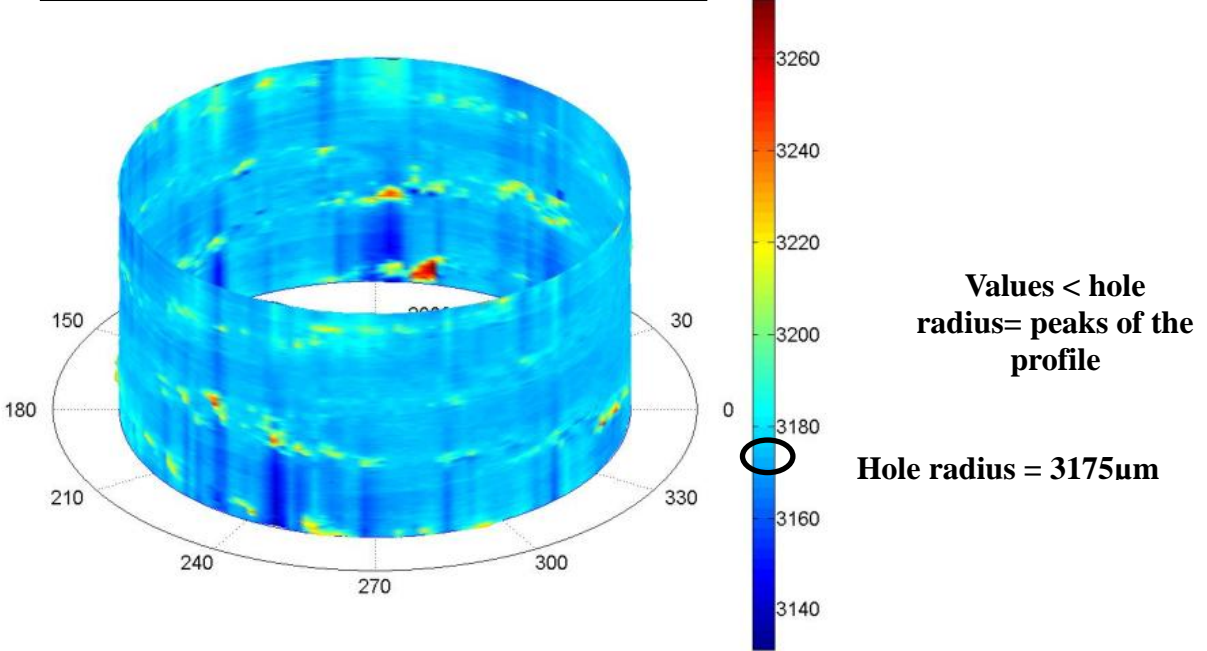
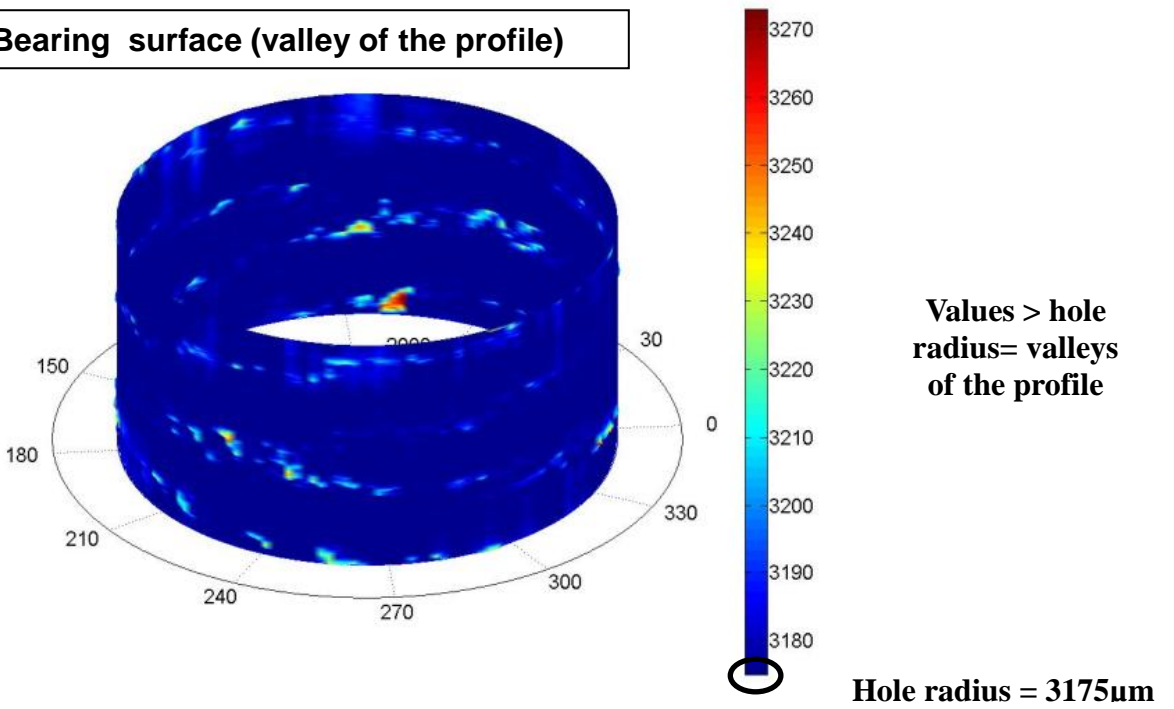
(a) Entire hole surface (peak +valley)

(b) Bearing surface (valley of the profile)

Fig. 18: Representation of a hole wall surface and the bearing surface of the same hole

Figure 18 shows an example of hole wall mapping in a cylindrical coordinate system. Figure 18a represents the total hole wall surface (peaks and micro-cavities) and Figure 18b represents the bearing surface as described above. These maps can be thought of as the result of taking an impression of the hole wall. Thus the external rough edges of the maps represent the valleys of the profile and the internal rough edges represent the peaks of the profile. The interest of this criterion is that it can be calculated on the entire surface of the hole and also on

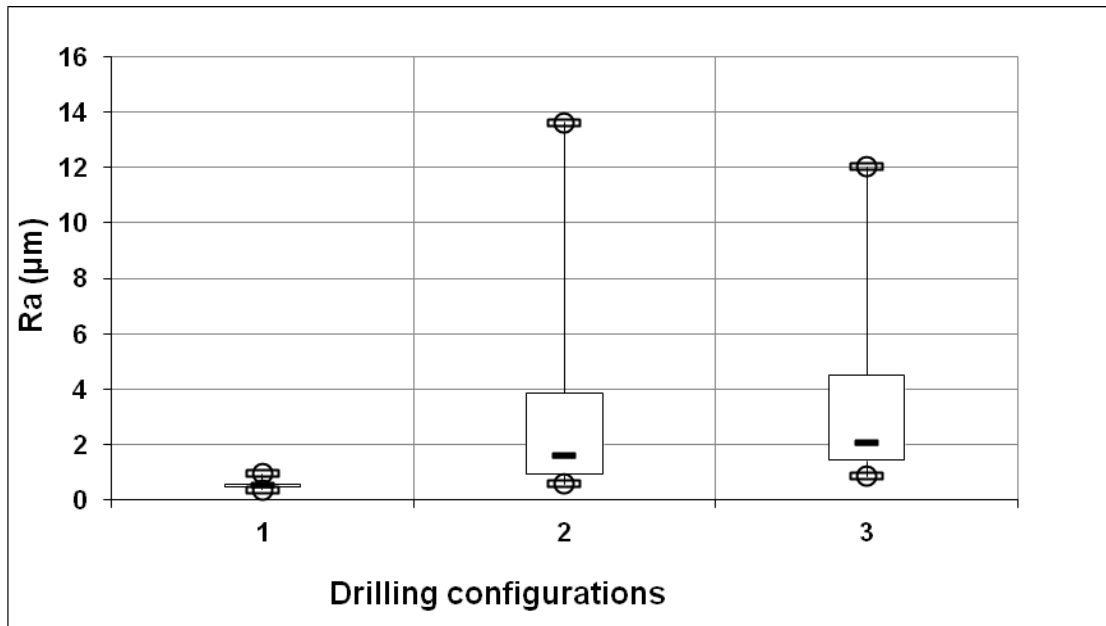
Fig. 20: Influence of the drilling conditions on Ra

The influence of the drilling parameters (see Table 1) on the roughness criterion R_a is shown in Figure 20 using a classical statistical box and whisker presentation (mustache boxes). The roughness (R_a) was measured for three specimens per drilling configuration. The graph of Figure 20 presents the evolution of the mean of R_a according to the drilling configuration applied (for 3×240 measurements). A first point that can be noted is that the roughness (R_a) increases when the feed speed increases. It seems that the $R_{a_{\max}}$ of the specimens of drilling configuration 2 is higher than the $R_{a_{\max}}$ of the specimens of configuration 3. However, the box plots show that, for the specimens of drilling configuration 3, the minimum values of R_a , and 75% of all R_a values, are higher than those of the specimens of drilling configuration 2. This means that the surface finish of the specimens of drilling configuration 3 is generally worse than that of the specimens of configuration 2. A Student's test was conducted on the three batches of samples presented above in order to determine whether the R_a values of the 3 batches belonged to the same statistical population of R_a . This test, with a risk of 5%, assesses

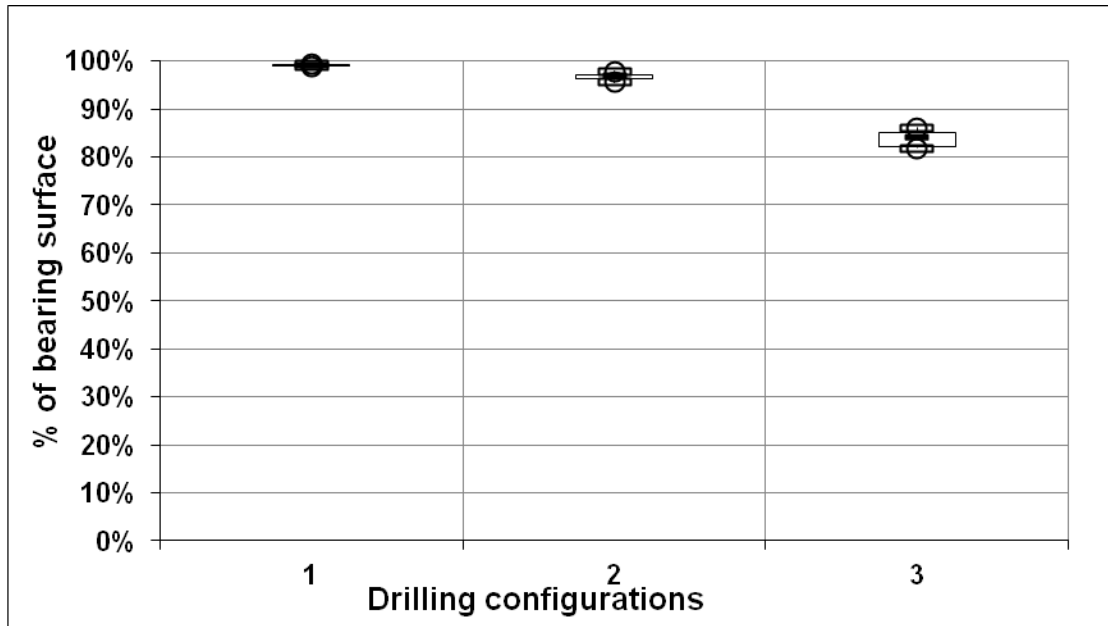
Fig. 21: Influence of the drilling conditions on the percentage of bearing surface

Table 2 shows the different p-values. The red values represent the cases where the hypothesis is verified. The specimens of drilling configurations 2 and 3 belong to the same Ra statistical population. The box plots representing the evolution of the percentage of bearing surface for the same specimens are presented in Fig. 22 21 in order to compare these results with those obtained regarding the Ra criterion. It can also be noted that, for the percentage of bearing surface, drilling configurations 1 and 2 give relatively close bearing surfaces, the average difference of percentage of bearing surface between the configurations 1 and 2 being about 3.74%. This difference is 10.74% on average between configurations 1 and 3.

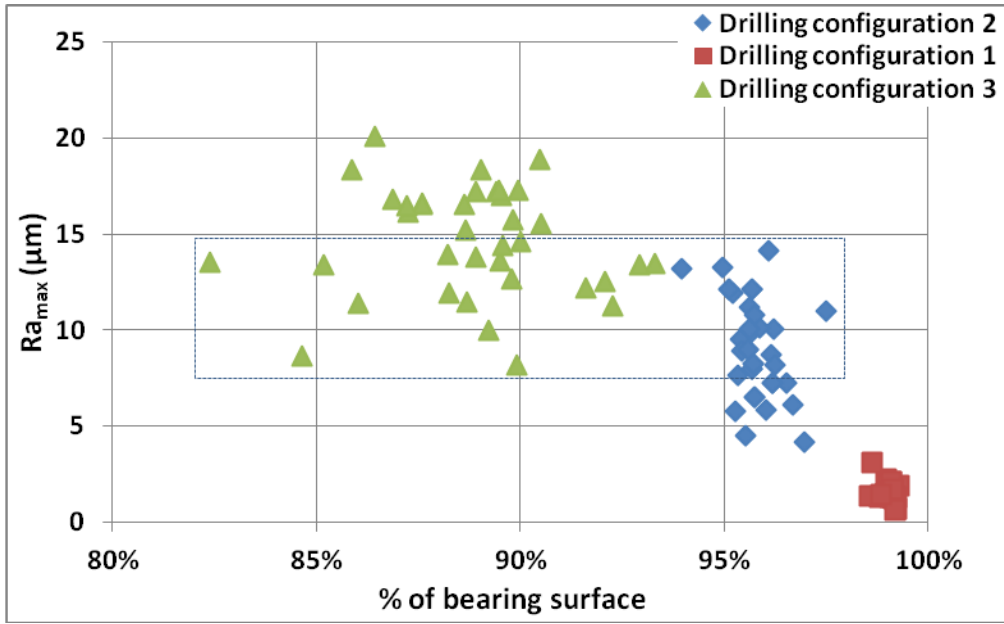
Fig. 22: Evolution of Ra versus the percentage of bearing surface

In order to observe the evolution of Ra according to the percentage of bearing surface, a hundred specimens were drilled, covering the three drilling configurations described above. The interest of this approach was to assess whether the roughness evolved with the same trend as the percentage of bearing surface. This could assess the feasibility of correlation between values of percentage of bearing surface and intervals of roughness values. Fig. 22 shows the result of this study. In some cases, the same range of Ra values corresponds to different values of percentage of bearing surface. Moreover, given that the highest values of Ra do not

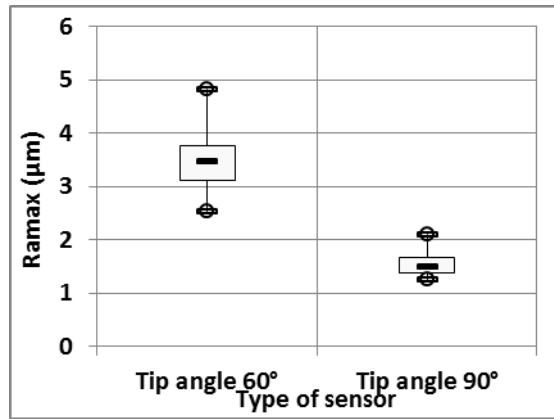
Fig. 23: Influence of stylus tip geometry on Ra values

Given that the roughness values also depend on the type of stylus used (the tip angles of the stylus can vary, e.g. 60° or 90°), the values obtained with two types of stylus were compared for the same specimens. Twenty specimens were measured twice, the first time with a stylus of 60° tip angle and the second time with a stylus of 90° tip angle. Figure 23 shows the result for the Ra criterion. We can see that Ra is sensitive to the stylus used. The Ra values measured using the 90° stylus are less than half those measured by the 60° stylus. The results of these measurements regarding the percentage of bearing surface are given in Figure 24. This criterion is less sensitive to stylus change and the maximum drop observed is about 2.78%.

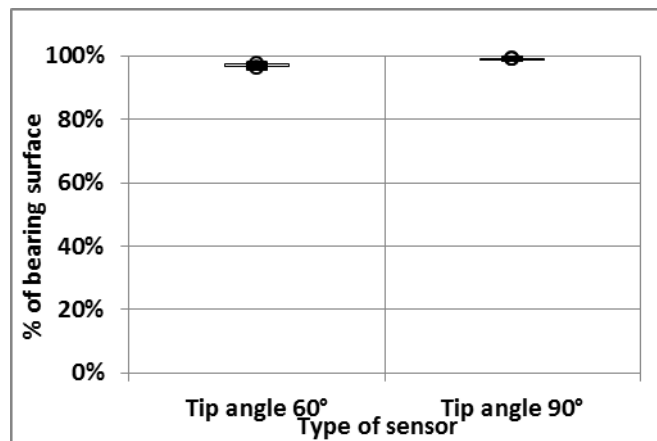
Fig. 24: Influence of stylus tip geometry on percentage of bearing surface.
